TECHNICAL REPORT M-238  
May 1978

FRACTURE CHARACTERISTICS OF ASTM A-607  
PIPELINE STEEL, ASTM A-516 STRUCTURAL STEEL,  
AND ASTM B-209, ALUMINUM ALLOYS 5083 AND 6061

by  
J. K. Scott

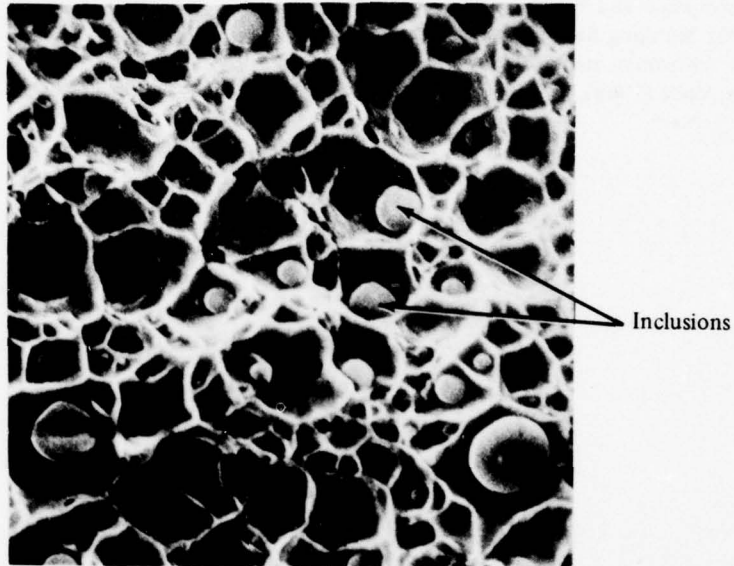
**Figure 1.** Typical equiaxed dimple structure containing inclusions, 4250X.

The shape of these dimples is strongly influenced by the orientation of the major stress axis in the individual grains and subgrains to the rolling direction of the material. Equiaxed dimples (Figure 1) result under local conditions of uniaxial tensile stress, while elongated dimples (Figure 2) result from failure caused by shear stress. Dimple size depends on the number of fracture nucleation sites, grain size, microstructure, and the relative ductility of the metal.

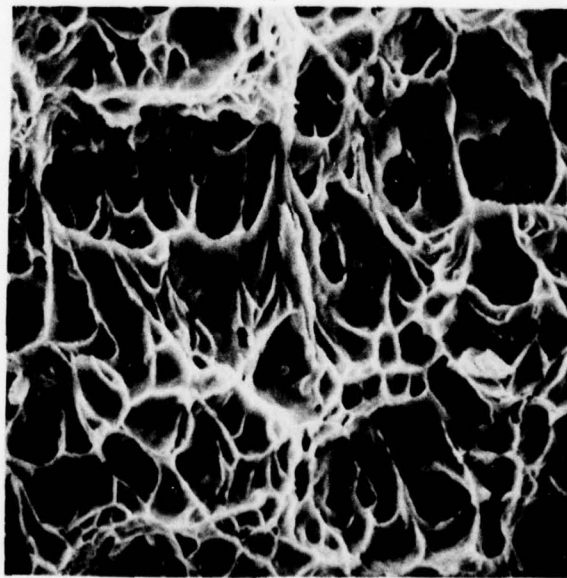
**Figure 2.** Typical elongated dimple structure, 3750X.

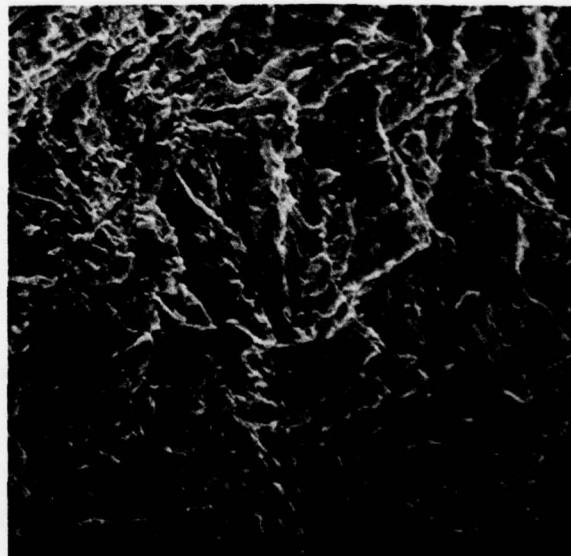
**Figure 4.** Typical fatigue striations, 4000X.

Fracture surface features can be divided into two categories according to the mode of fracture: transgranular (through the grains and across grain boundaries) or intergranular (around the grain boundaries). Transgranular fractures can occur by void coalescence, rupture, cleavage, or fatigue. Intergranular fractures occur by grain boundary separation either with or without microvoid coalescence. Figures 1 through 4 illustrate these types of fractures in metals.

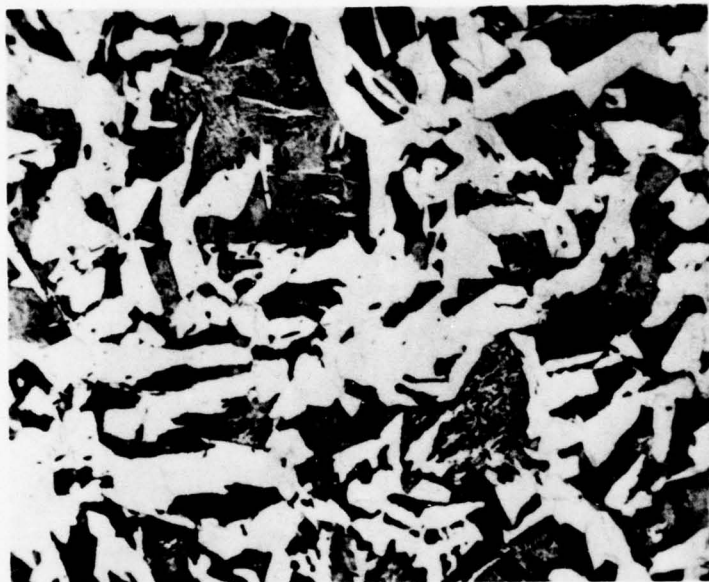
Figure 5. Microstructure of ASTM A-516 steel, 320X.

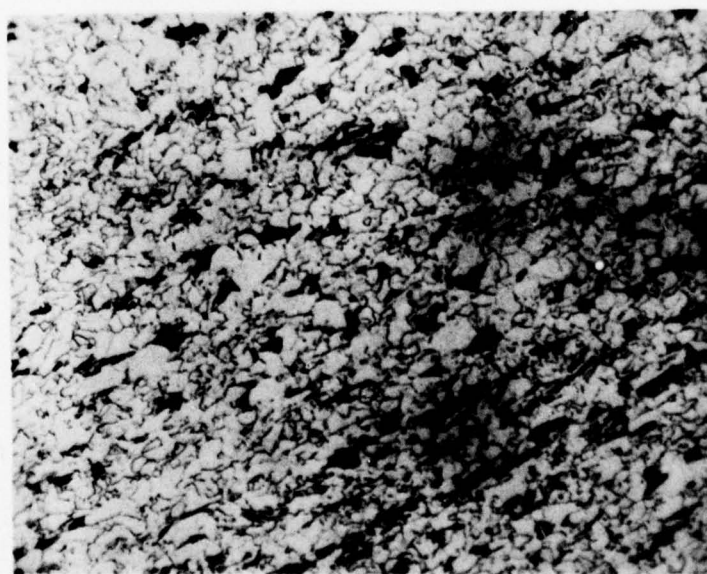
Figure 6. Microstructure of ASTM A-607 steel.

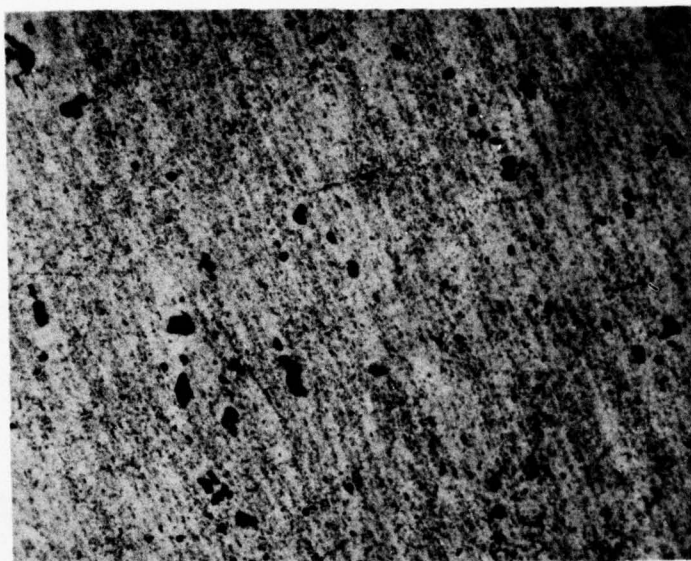
**Figure 7.** Microstructure of ASTM B-209, A1 alloy 5083.

Specimens of the ASTM A-516 and ASTM B-209, A1 alloys 5083 and 6061, were prepared from 1-in. (2.54-cm)-thick plates. The ASTM A-607 specimens were prepared from a 5/8-in. (1.59-cm)-thick pipe which had been cut and straightened. Type A-516 is a carbon steel intended primarily for use in welded pressure vessels where improved notch toughness is important. Its microstructure (Figure 5) consists of fine-grained ferrite. Type A-607 is a high-strength, low-alloy columbium and/or vanadium steel intended for use in structures where strength and savings in weight are important. Its as-received microstructure is fine-grained ferritic (Figure 6). Alloys 5083 and 6061 are structural aluminums used for sheet and plate. Their as-received structures are shown in Figures 7 and 8.

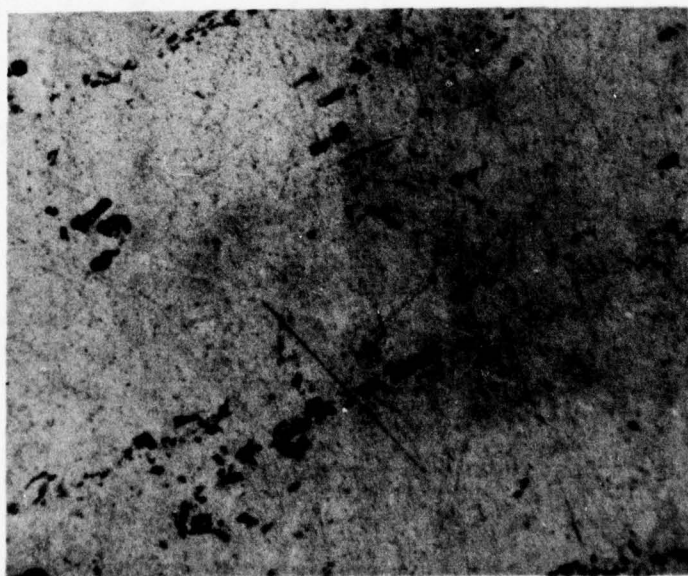
**Figure 8.** Microstructure of ASTM B-209, A1 alloy 6061.

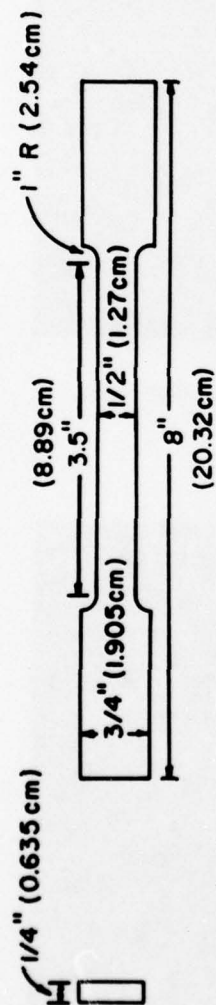
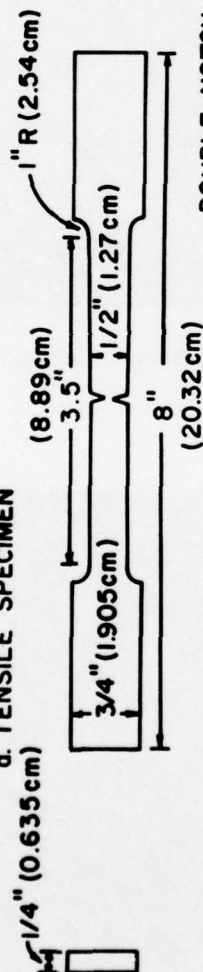
a. TENSILE SPECIMEN

DOUBLE NOTCH: 45°  
 .001 IN. ROOT RADIUS (0.254 mm)  
 1/8 IN. DEEP (3.175 mm)

b. FATIGUE SPECIMEN

c. CHARPY SPECIMEN

Figure 9. Specimen geometry for tensile, fatigue, and Charpy impact tests.

Figure 9 shows the specimen geometry for the tensile, impact, and fatigue tests. The specimens were machined with the specimens' longitudinal axes parallel to the rolling direction.

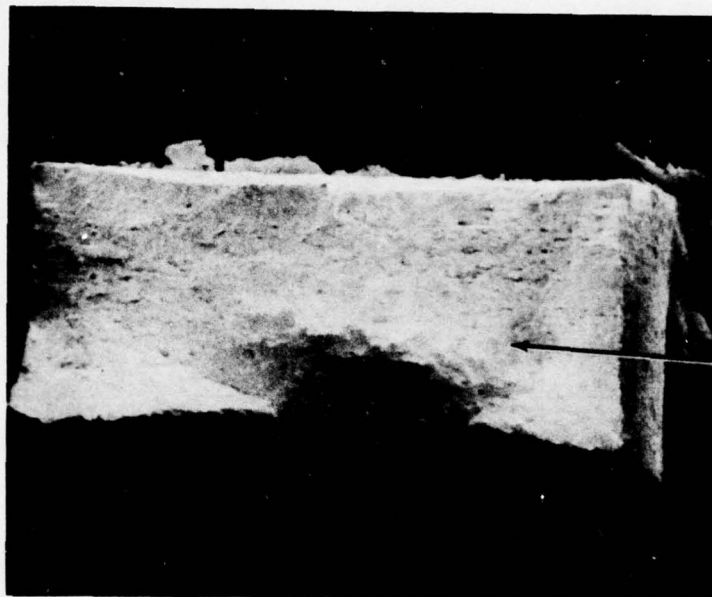
**Figure 10.** Tensile fracture surface of A-516 steel, 12X.

The fracture surface of the A-516 tensile sample is shown in Figure 10. Failure occurred by inclusion-generated dimple rupture. Figure 11 shows various dimple sizes and a large inclusion.

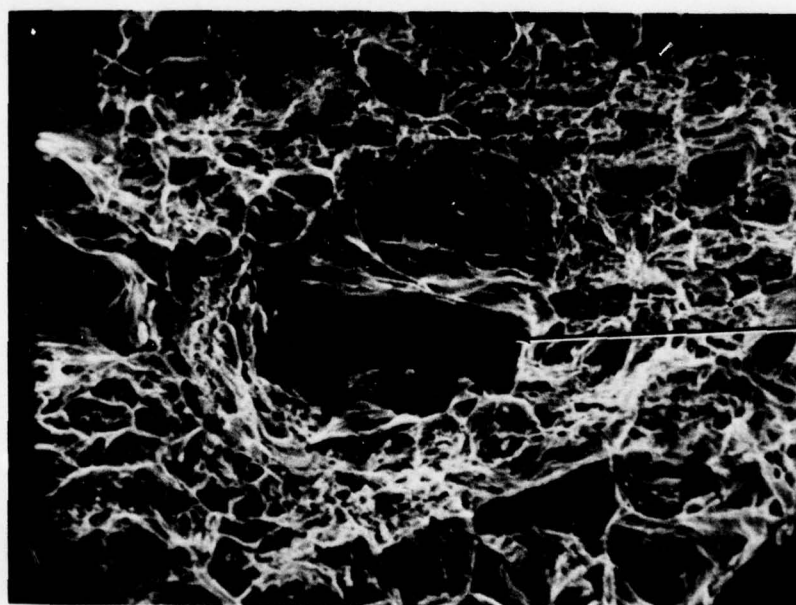
**Inclusion**

**Figure 11.** Dimple rupture in A-516 steel, 1200X.

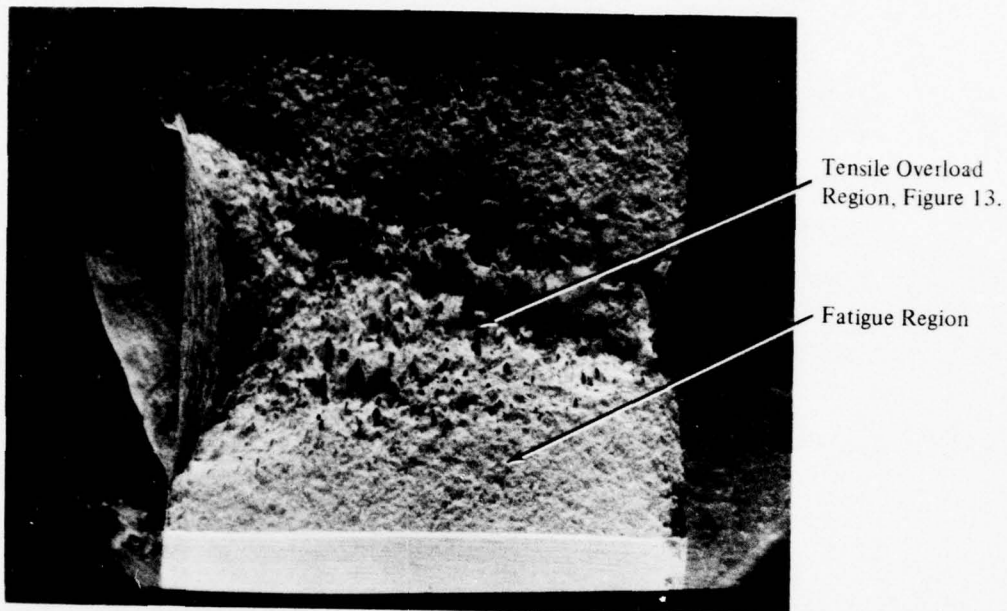
**Figure 12.** Fatigue fracture surface of A-516 steel, 8X.

Regions of fatigue and tensile overload can be identified on the fracture surface of the A-516 fatigue specimen (Figure 12). Failure in the tensile overload regions occurred by dimple rupture which initiated at inclusions (Figure 13). Failure in the fatigue regions consisted primarily of transgranular fracture (Figure 14).

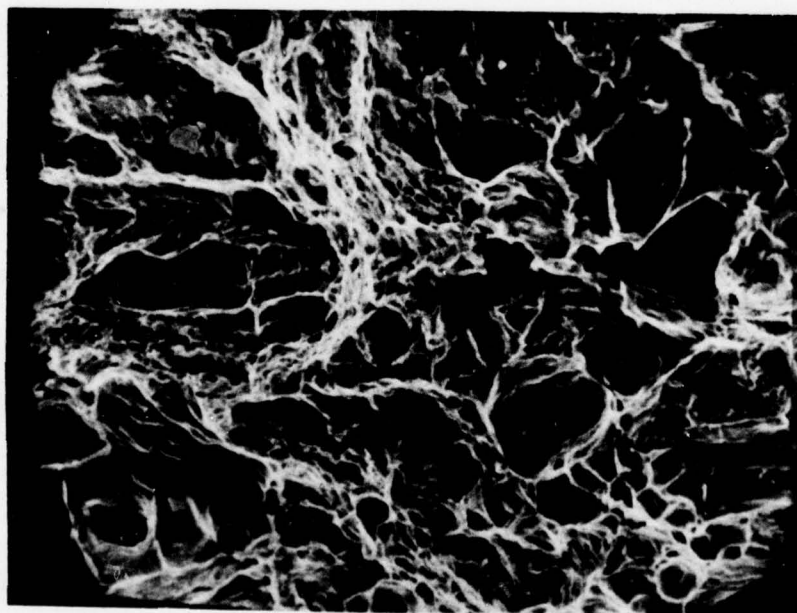
**Figure 13.** Dimple rupture in an A-516 fatigue specimen, 1000X.

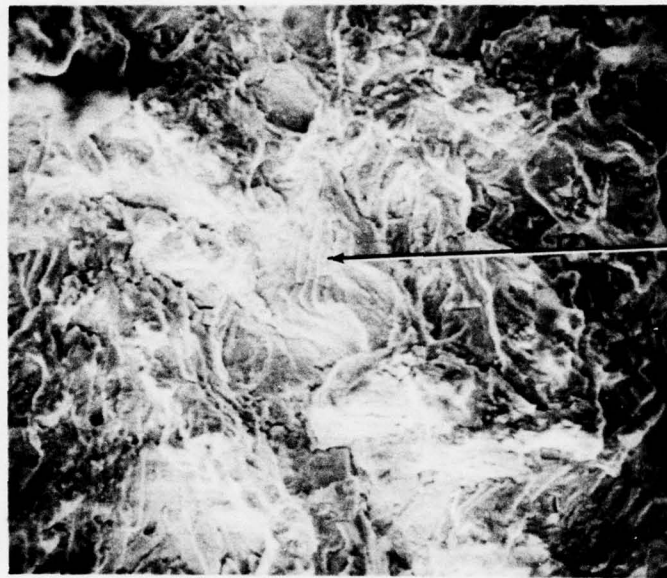
Fatigue Striae

**Figure 14.** Transgranular fracture in an A-516 fatigue specimen, 650X.

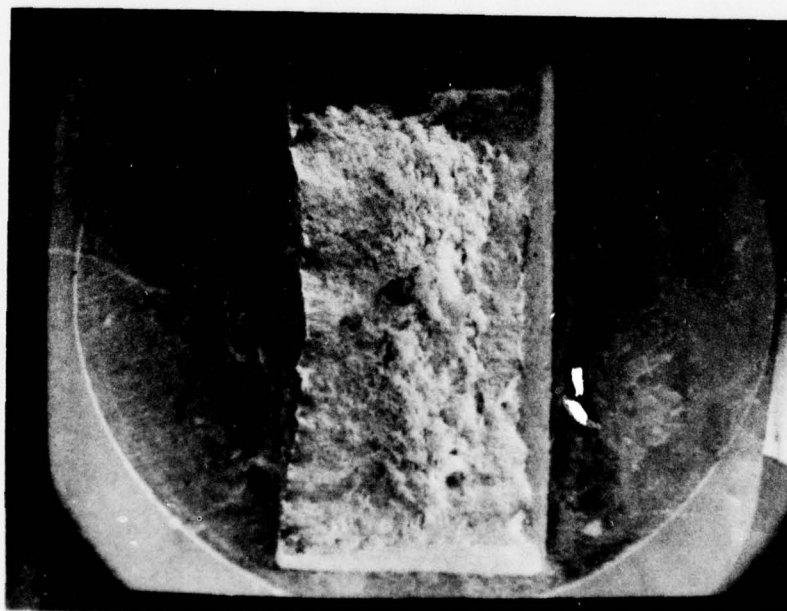
**Figure 15.** Tensile fracture surface of hydrogen-embrittled A-516 steel, 11X.

The fracture surfaces of the hydrogen-embrittled A-516 tensile (Figure 15) and fatigue (Figure 16) specimens were very similar to the unembrittled tensile and fatigue specimens. Failure in the hydrogen-embrittled tensile specimen occurred by inclusion-generated dimple rupture (Figure 17). A fractured pearlite colony can also be identified on this fracture surface. Regions of tensile overload and fatigue were found on the hydrogen-embrittled fatigue specimen surface. Failure occurred by dimple rupture in the tensile overload region and by transgranular fracture in the fatigue region. Some areas of fatigue striae were found in the fatigue region; the fatigue striae indicate a stepwise, cyclic progression of the crack front across the fracture surface (Figure 18).

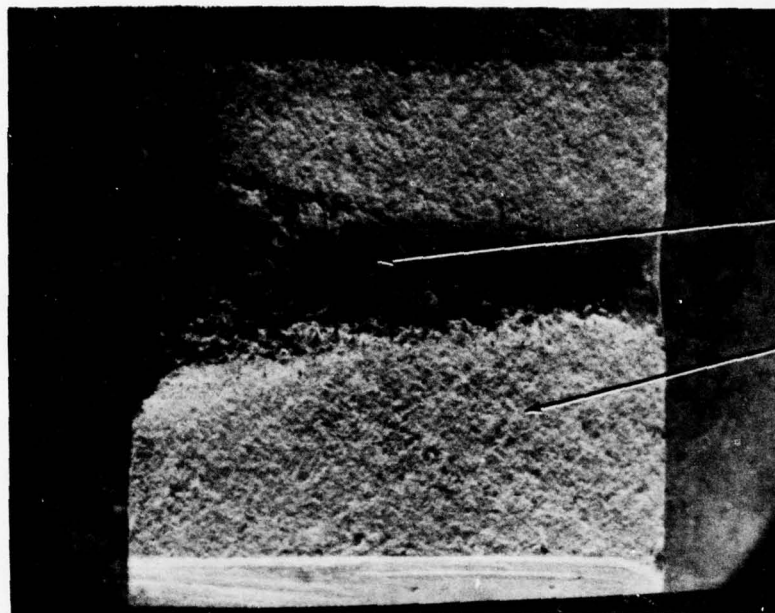
Tensile Overload  
Region, Figure 17.

Fatigue Region,  
Figure 18.

Figure 16. Fatigue fracture surface of hydrogen-embrittled A-516 steel, 12X.

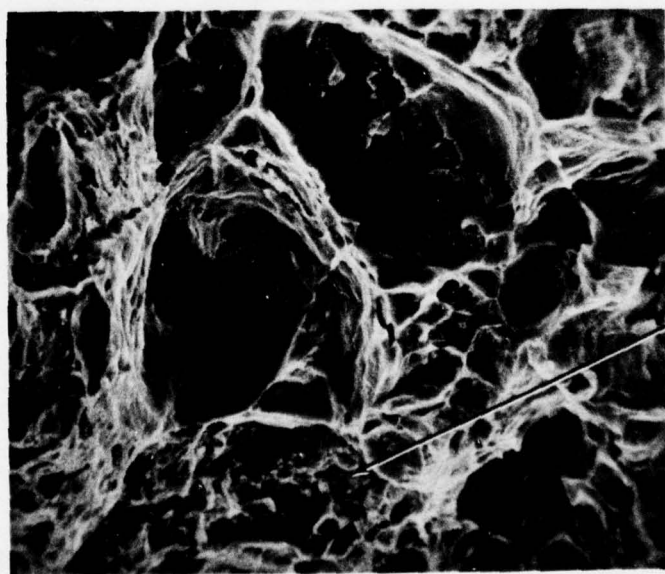
Fractured Pearlite  
Colonies.

Figure 17. Dimple rupture in a hydrogen-embrittled A-516 steel, 800X.

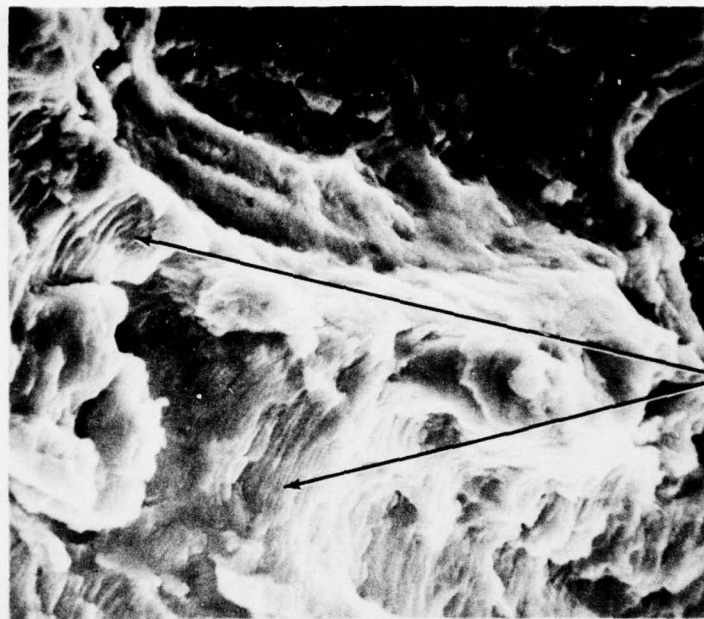
Fatigue  
Striations

Figure 18. Fatigue striations in A-516 steel, 1800X.

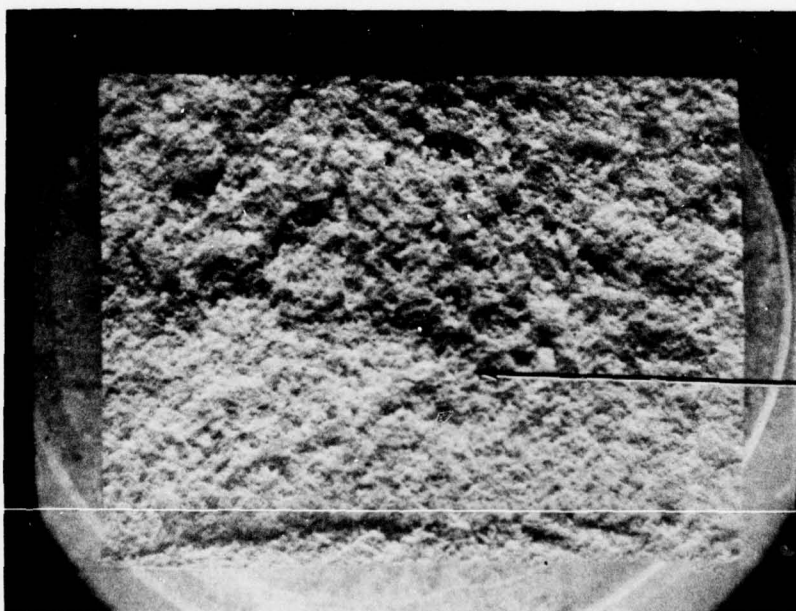
Figure 20

Figure 19. Fracture surface of an A-516 Charpy specimen tested at  $-196^{\circ}\text{C}$ , 11X.

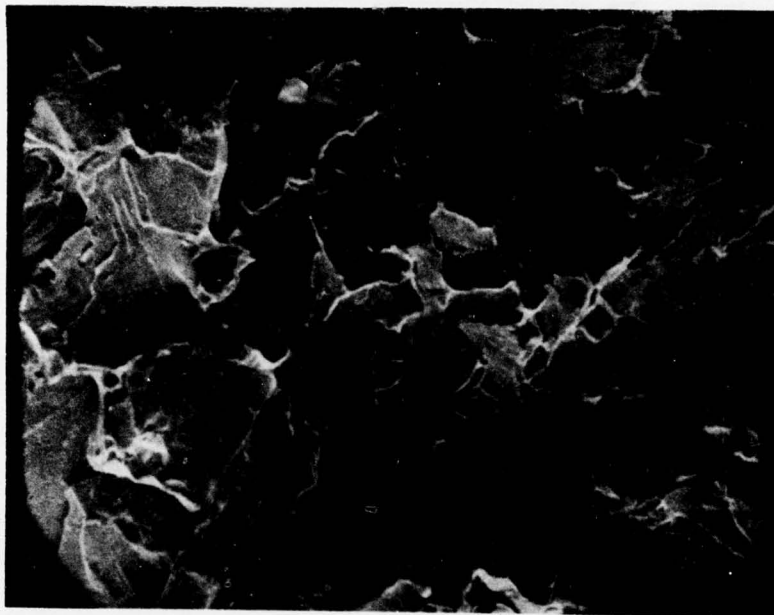
**Figure 20.** Cleavage facets in an A-516 Charpy specimen tested at  $-196^{\circ}\text{C}$ , 550X.

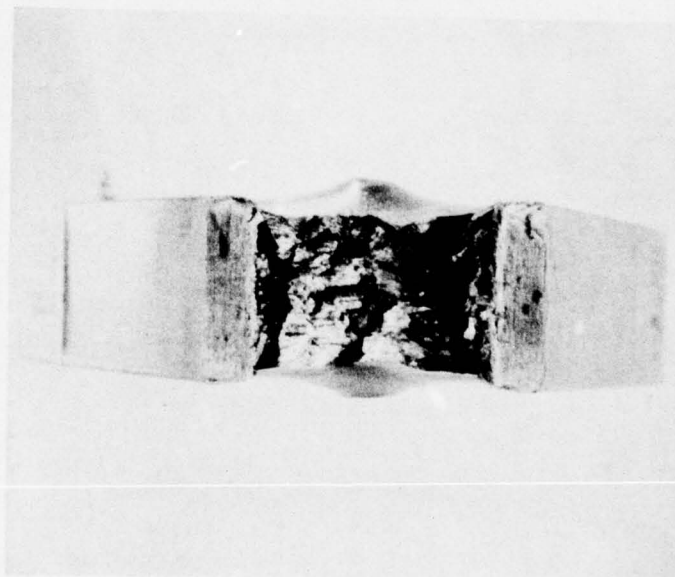
**Figure 21.** A-516 steel Charpy impact specimen tested at  $0^{\circ}\text{C}$ , 11X.

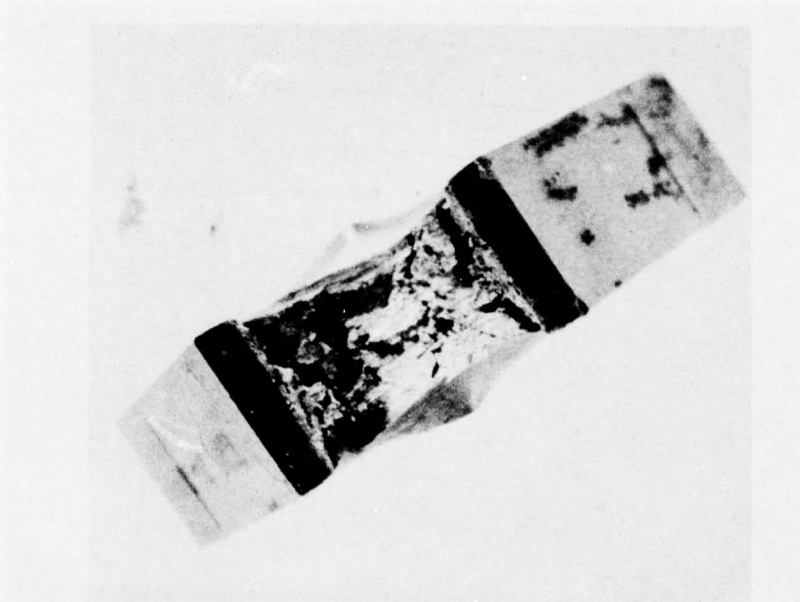
**Figure 22.** A-516 steel Charpy impact specimen tested at 25°C, 11X.

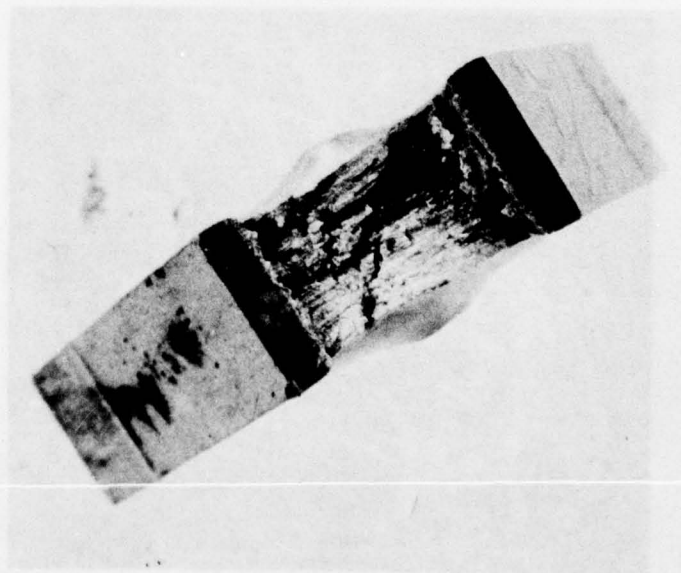
**Figure 23.** A-516 steel Charpy impact specimen tested at 100°C, 11X.

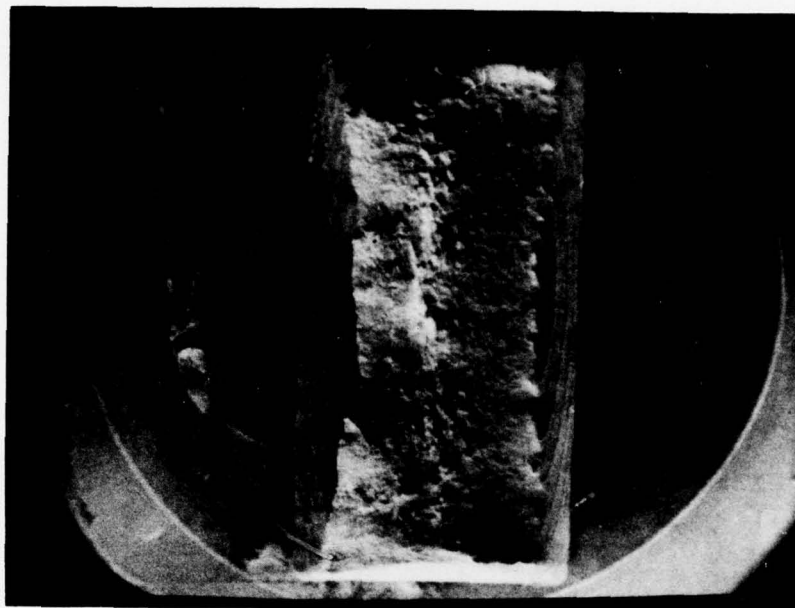
**Figure 24.** Tensile fracture surface of A-607 steel, 11X.

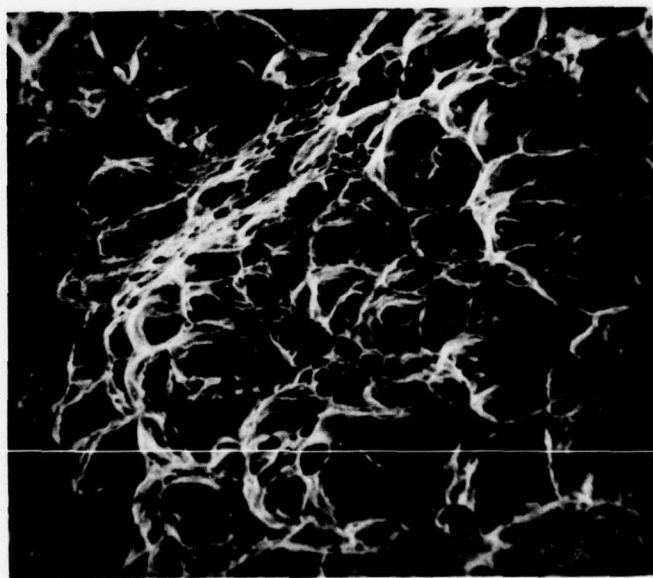
**Figure 25.** Dimple rupture in A-607 steel, 800X.

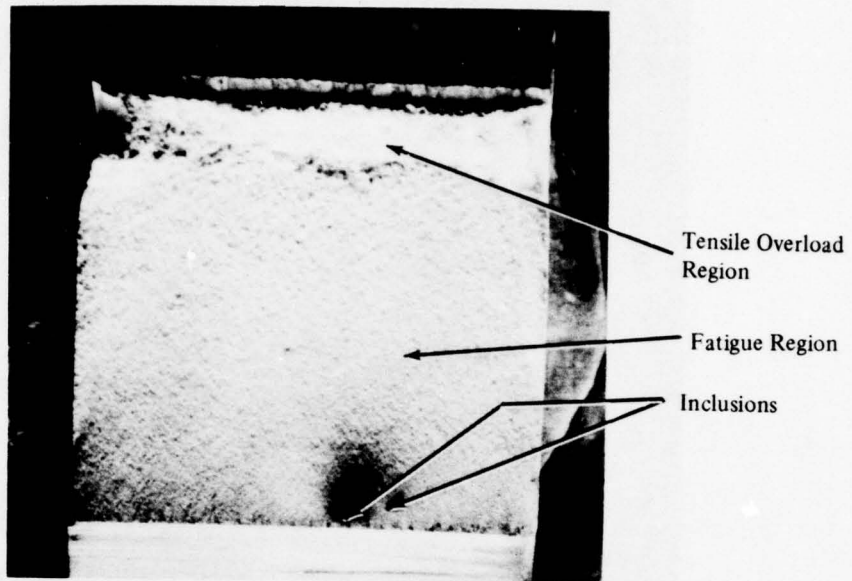
Figure 26. Fatigue fracture surface of A-607 steel, 12X.

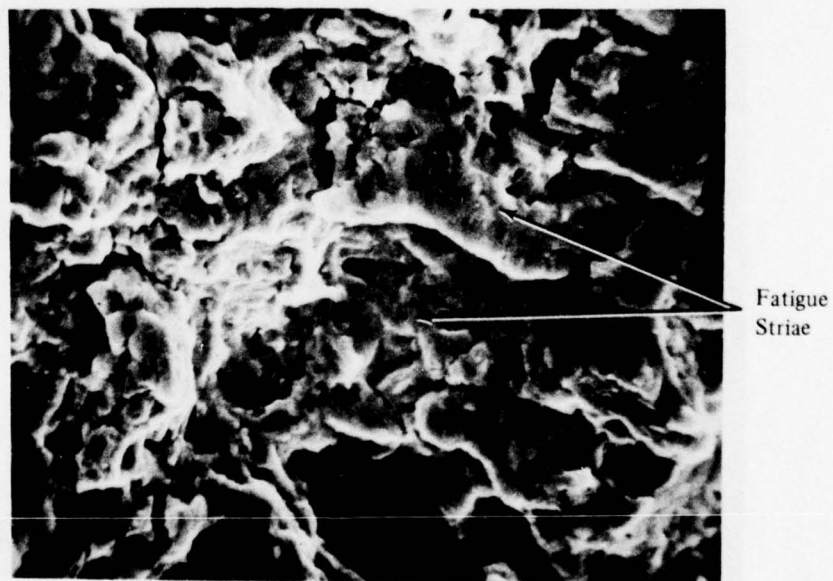
Figure 27. Fatigue striations in A-607 steel, 1000X.

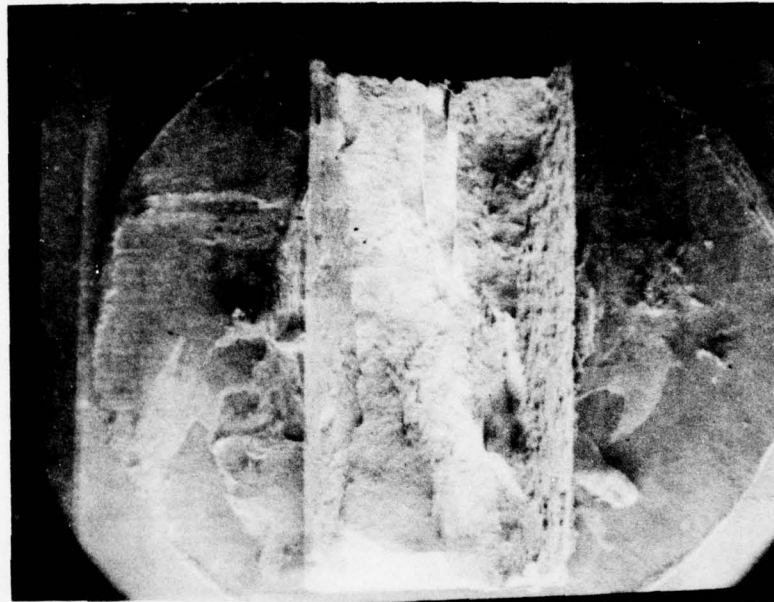
Figure 28. Hydrogen-embrittled tensile A-607 steel specimen, 11X.

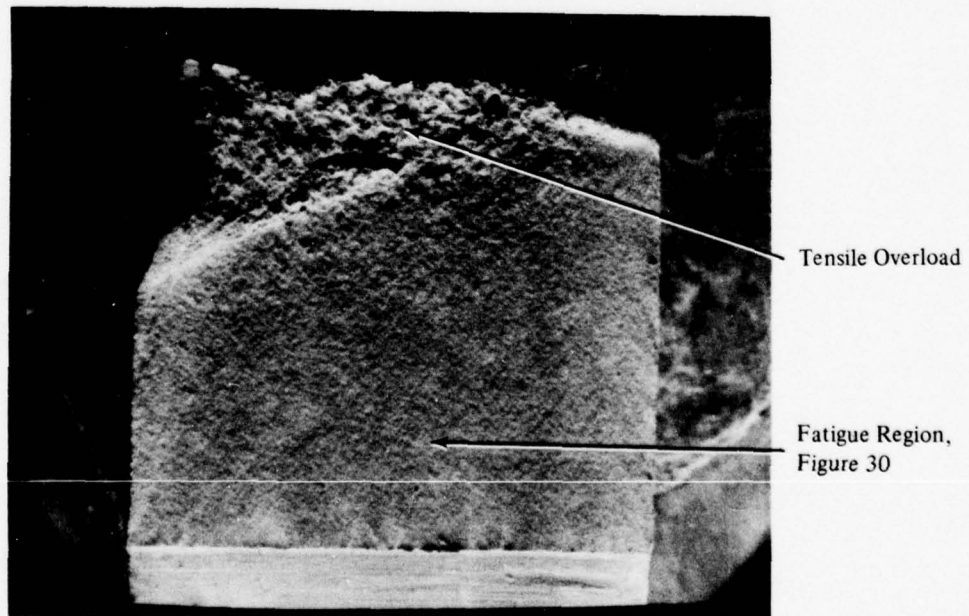
Figure 29. Hydrogen-embrittled fatigue A-607 steel specimen, 12X.

The hydrogen-embrittled fatigue specimen (Figure 29) showed the large region of fatigue on one side, again indicative of an inclusion initiating rapid fatigue. More distinct fatigue striae are seen in the hydrogen-embrittled sample (Figure 30) than in the unembrittled sample.

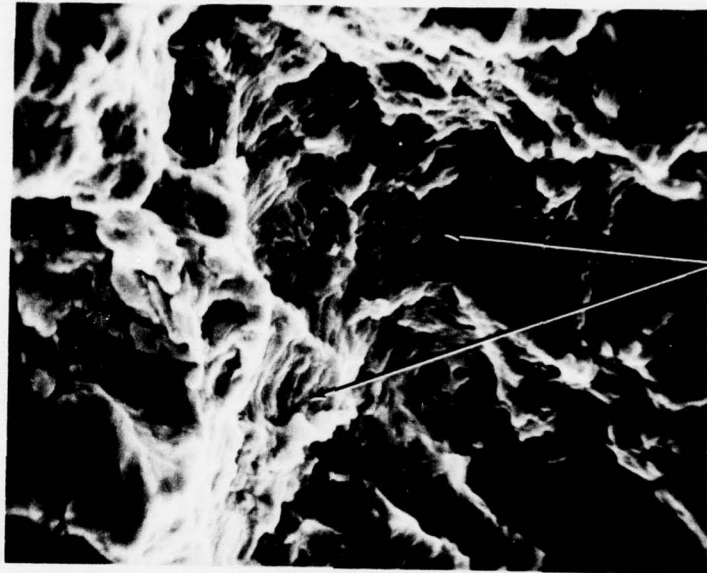
Fatigue  
Striae

**Figure 30.** Fatigue striae in a hydrogen-embrittled A-607 steel specimen, 1000 X.

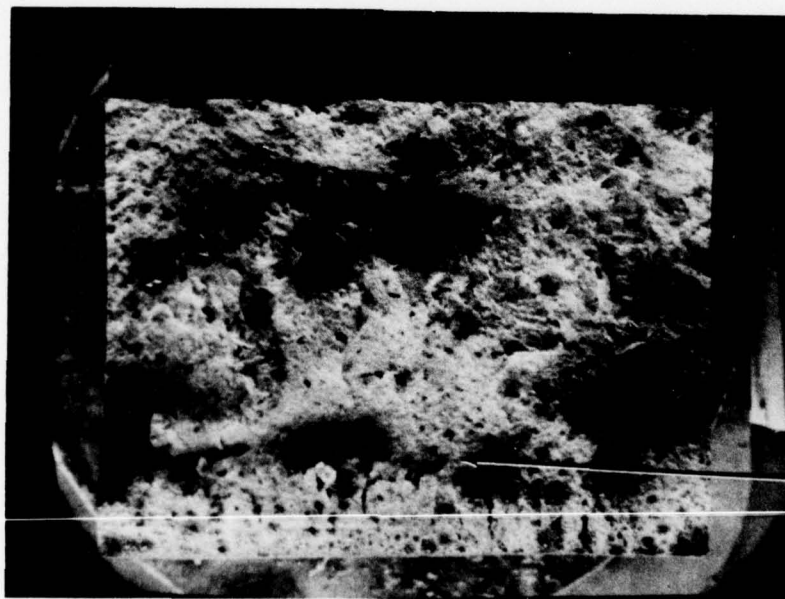
Figure 32

**Figure 31.** A-607 Charpy impact specimen tested at  $-196^{\circ}\text{C}$ , 11X.

The as-received ASTM A-607 Charpy impact specimens showed increasing plastic deformation with increasing testing temperature. Failure occurred by cleavage in the  $-196^{\circ}\text{C}$  specimen (Figures 31 and 32), and by dimple rupture in the higher temperature specimens (Figures 33 through 38). The dimple rupture and increase in shear lip size with increasing testing temperature is evidence of the increasing plastic deformation and increasing ductility.

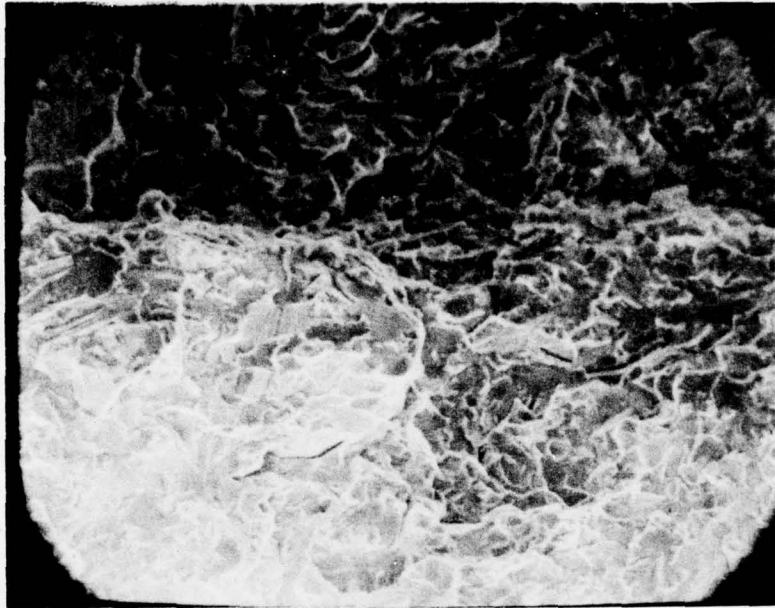
**Figure 32.** Cleavage facets in an A-607 Charpy impact specimen tested at  $-196^{\circ}\text{C}$ , 550X.

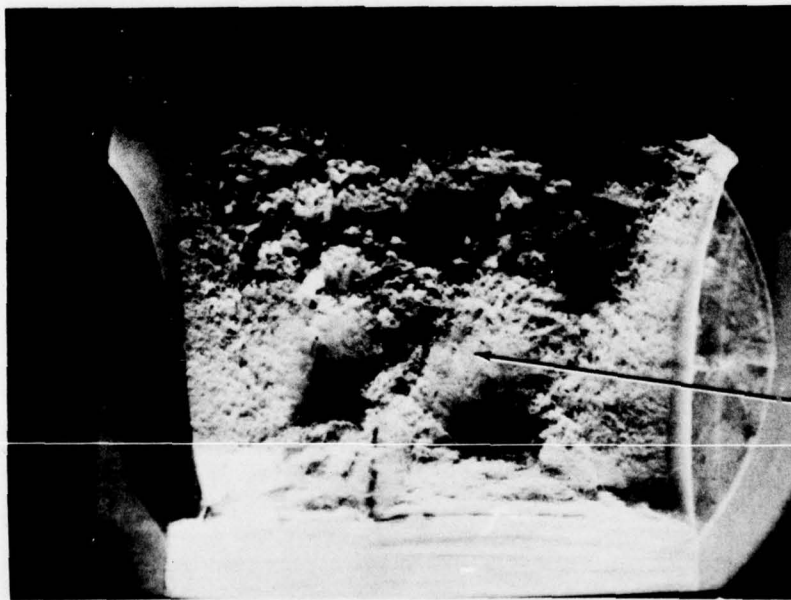
**Figure 34**

**Figure 33.** A-607 Charpy impact specimen tested at  $0^{\circ}\text{C}$ , 9X.

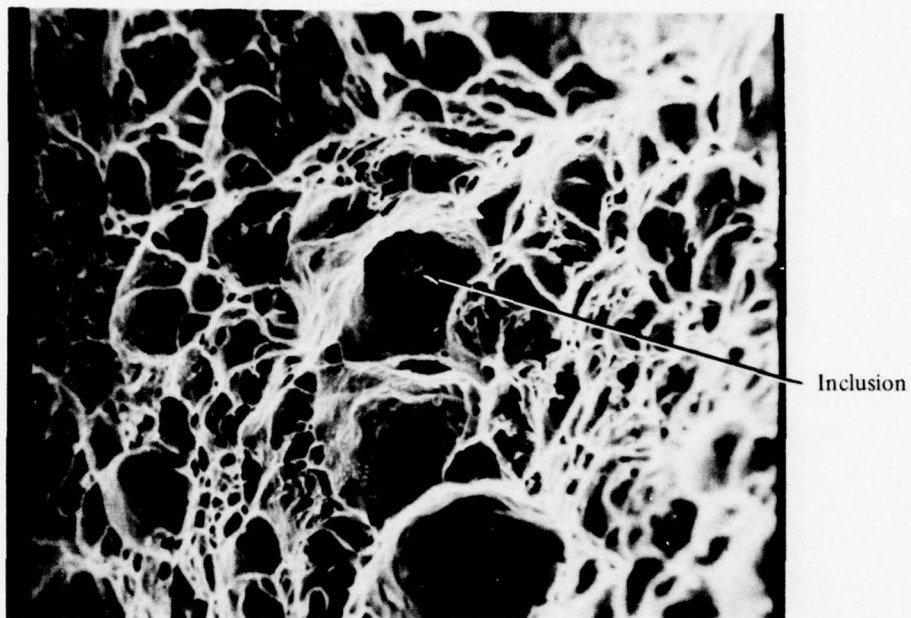
**Figure 34.** Dimple rupture in an A-607 Charpy impact specimen tested at 0°C, 300X.

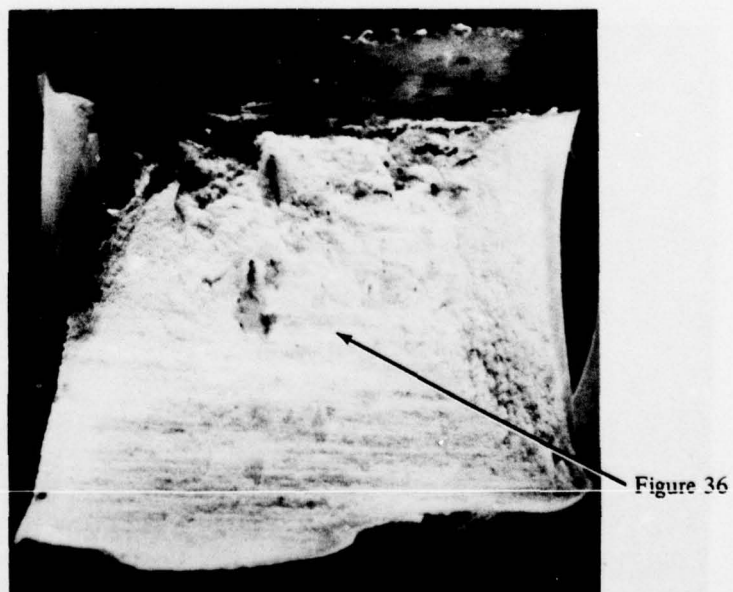
**Figure 35.** A-607 Charpy impact specimen tested at 25°C, 10X.

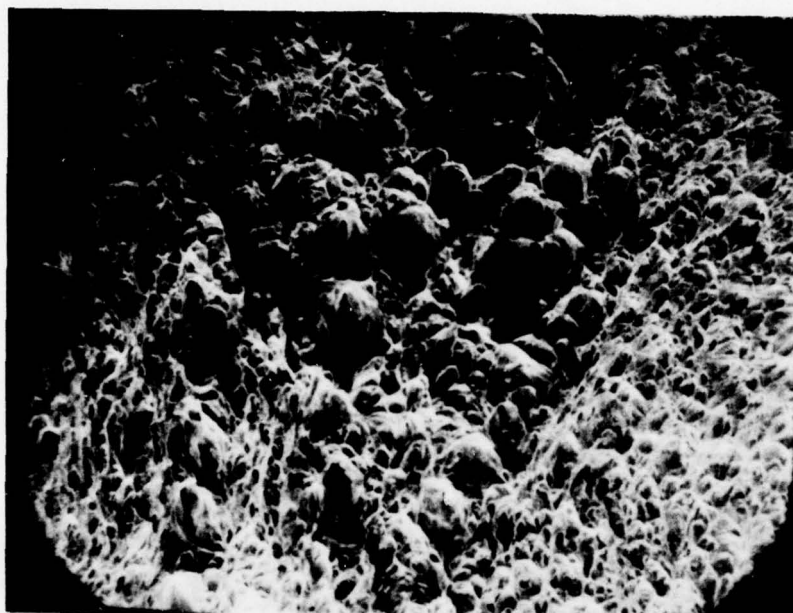
**Figure 36.** Dimple rupture in an A-607 Charpy impact specimen tested at 25°C, 250X.

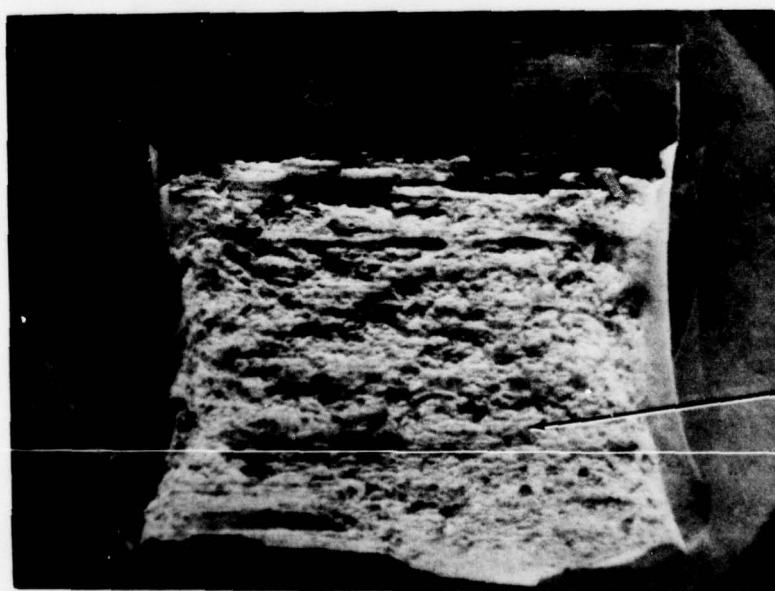
**Figure 37.** A-607 Charpy impact specimen tested at 100°C, 10X.

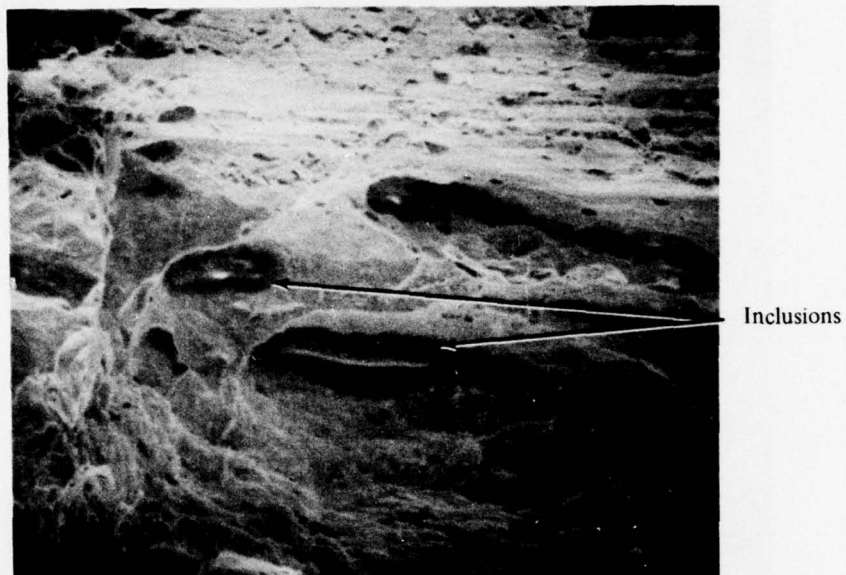
**Figure 38.** Dimple rupture and a large inclusion in an A-607 Charpy impact specimen tested at 100°C, 500X.

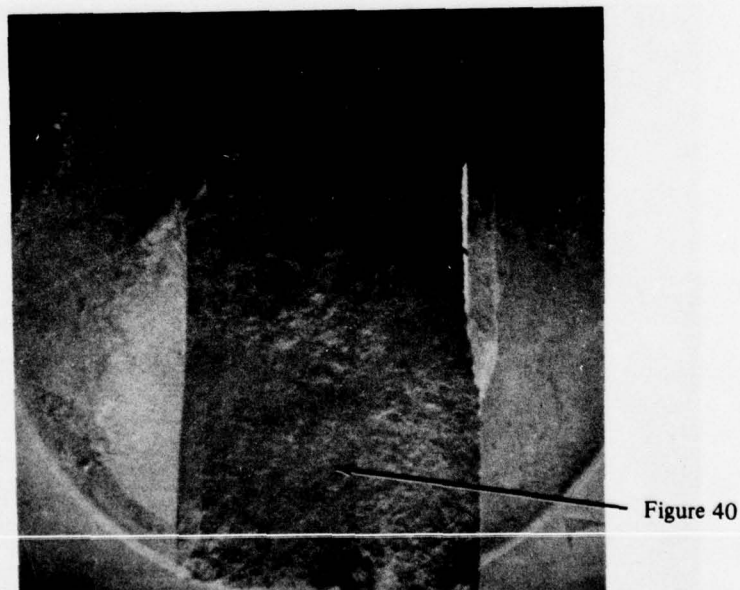
**Figure 39.** Tensile fracture surface of a 5083 aluminum specimen, 9X.

The failure of the as-received aluminum 5083 tensile specimen was very ductile, producing an extremely slanted fracture surface (Figure 39). A higher magnification of the surface (Figure 40) shows an elongated dimple rupture structure.

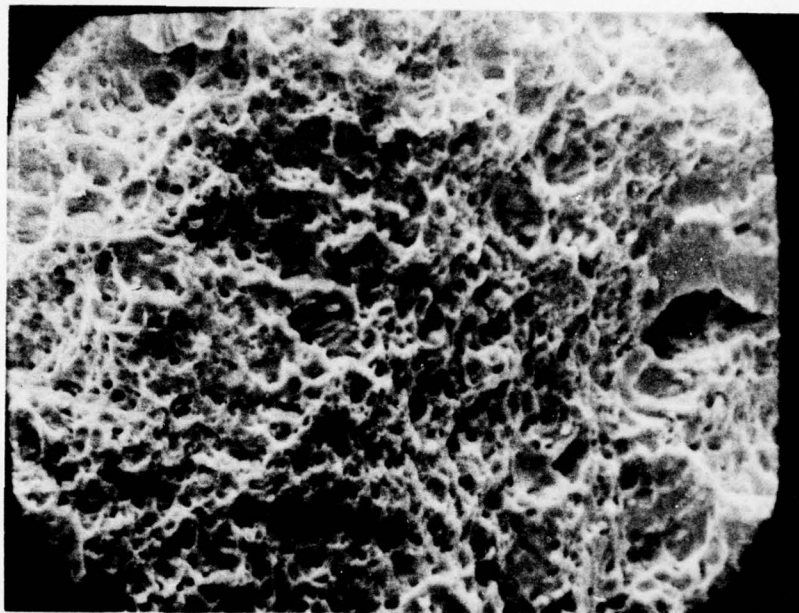
**Figure 40.** Dimple rupture in 5083 aluminum, 450X.

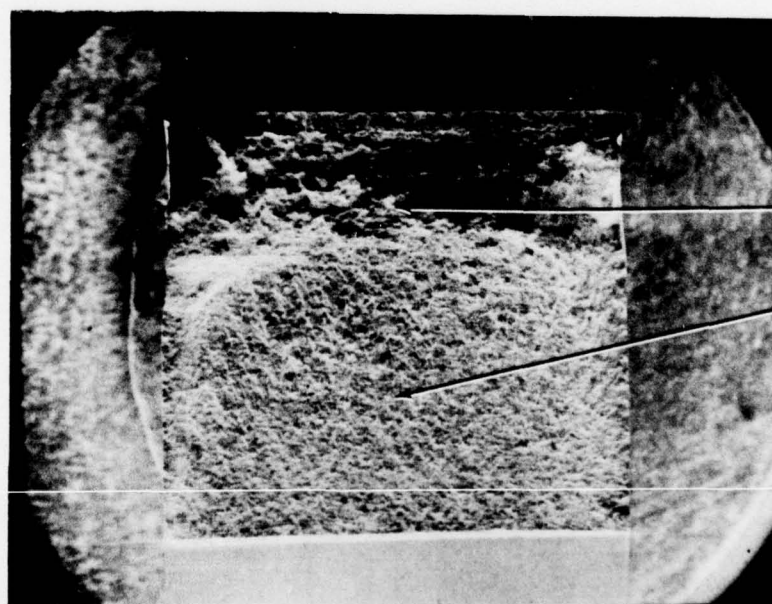
**Figure 41.** Fracture surface of 5083 aluminum tensile specimen, 12X.

The fracture surface of the as-received aluminum 5083 specimen shows the typical regions of tensile overload and fatigue (Figure 41). Failure occurred by inclusion-generated dimple rupture in the tensile overload region (Figure 42). The fatigue region shows very definite regions of fatigue striae, as shown in Figures 43 and 44.

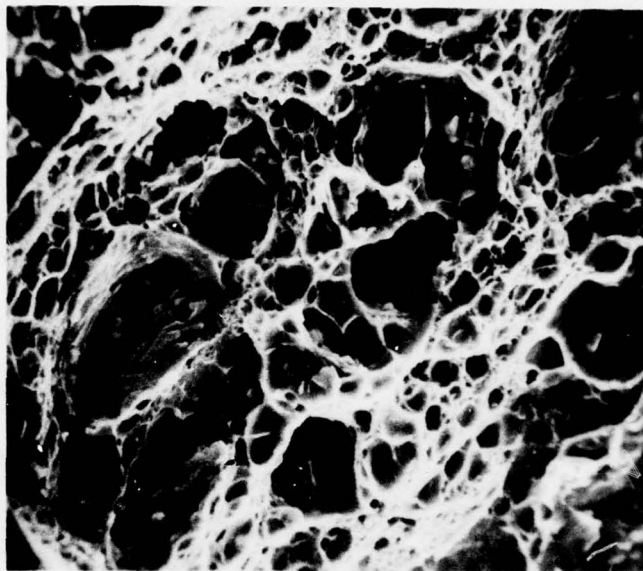
**Figure 42.** Dimple rupture in 5083 aluminum, 300X.

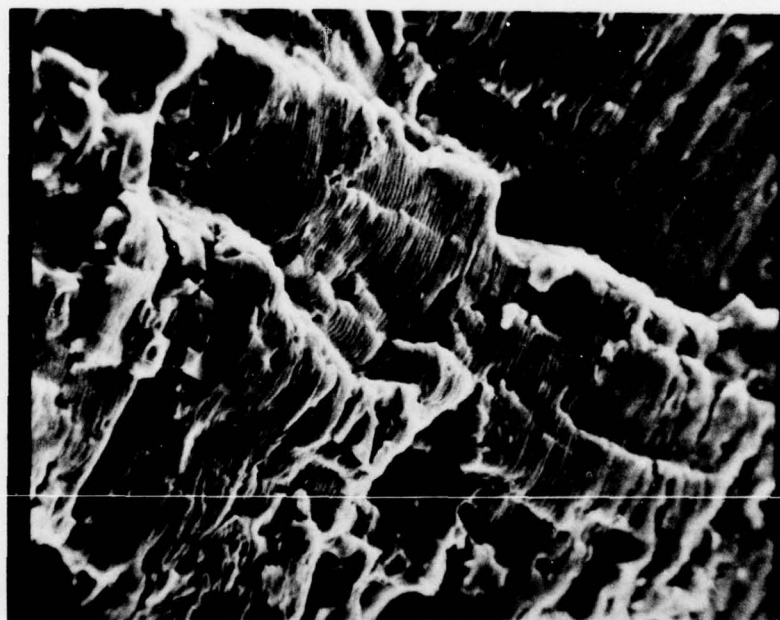
**Figure 43.** Fatigue striae in 5083 aluminum, 300X.

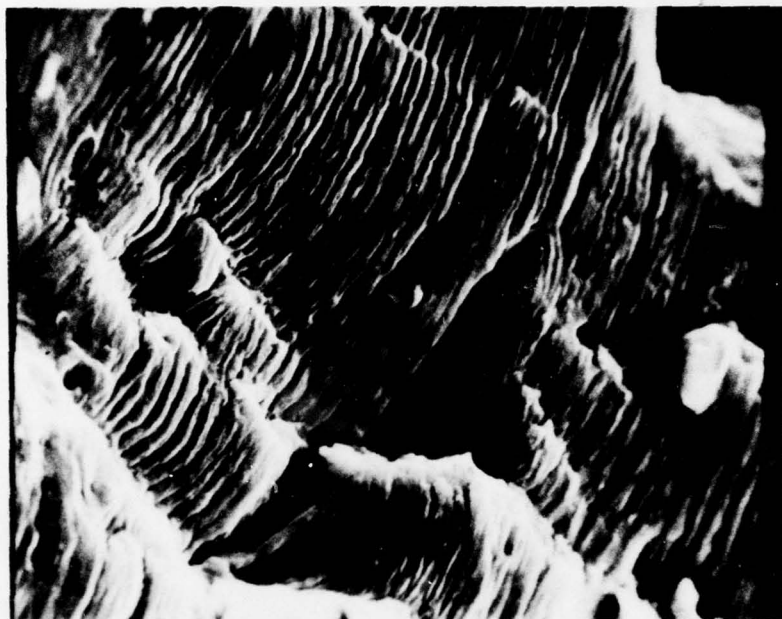
**Figure 44.** Fatigue striae in 5083 aluminum, 1000X.

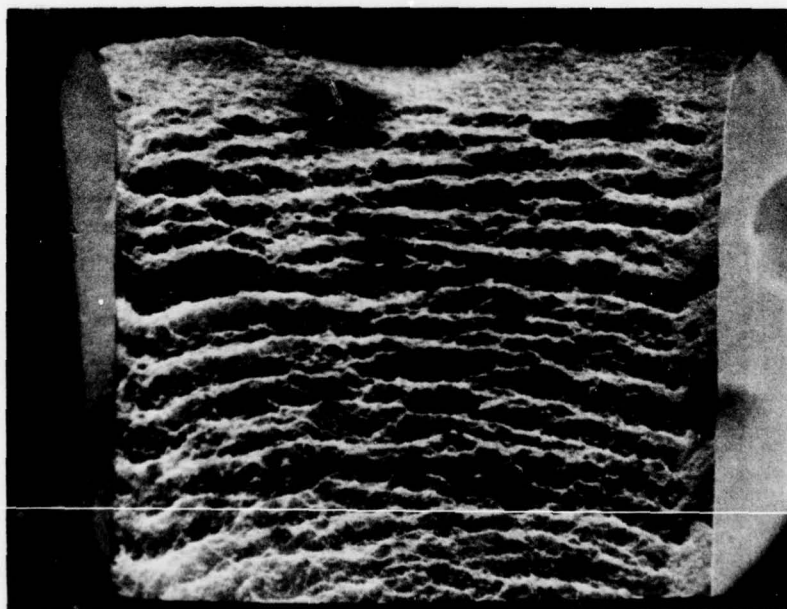
**Figure 45.** 5083 aluminum Charpy impact specimen tested at  $-196^{\circ}\text{C}$ , 10X.

The aluminum 5083 Charpy impact specimens all failed in a ductile manner. The  $-196^{\circ}\text{C}$  specimen had a very slanted surface whose layers indicated tearing along the grain structure (Figure 45). This is the result of large amounts of second phases congregating in the grain boundaries as shown in the microstructure in Figure 7. At this low temperature, the failure propagates through the less cohesive grain boundaries. The remaining specimens have a fibrous appearance indicating some influence of grain boundary tearing (Figures 46, 47, and 48). Failure occurs primarily by dimple rupture, and the surfaces indicate increasing plastic deformation as demonstrated by increasing shear lip size.

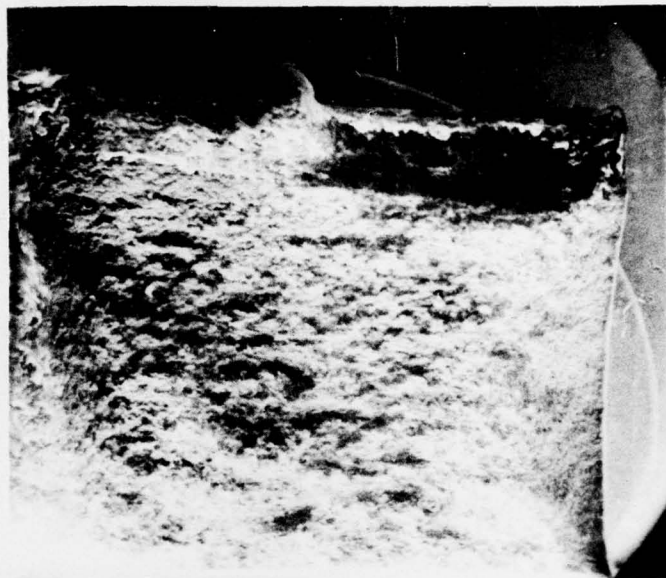
**Figure 46.** 5083 aluminum Charpy impact specimen tested at 0°C, 11X.
